# CENTER FOR ETHIOPIAN RIFT VALLEY STUDIES (CERVaS)

## Volume 1, Issue 1

# Analysis of Land Use/Land Cover Change Dynamics and Underlying Driving Forces in the Lake Hawassa Watershed, Ethiopia, Based on Satellite Remote Sensing and GIS Techniques<sup>1</sup>

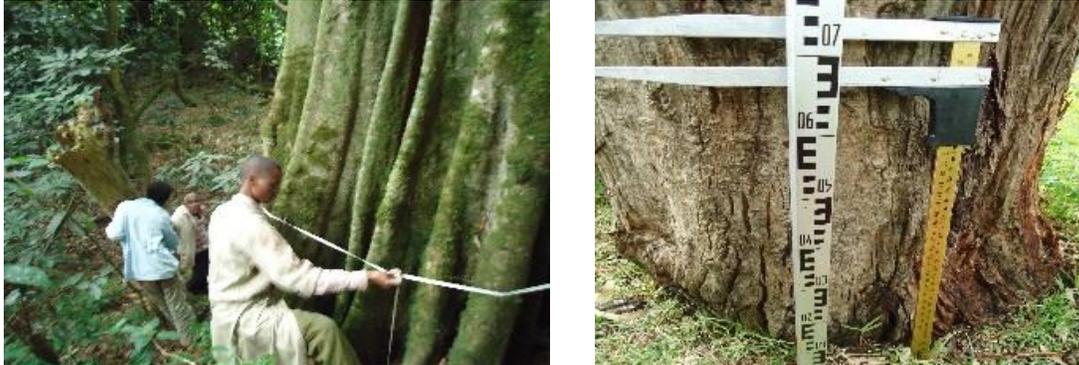
Figure 2. Measurement of tree variables and key informant interviewing (Photo by the author, 2013)

- i. Data for the classification and accuracy assessment of LULC maps (training areas and reference points),
- ii. Data for the estimation of AGB (tree variables such as diameter at breast height and height), and
- iii. Key informant interviews were conducted to collect the possible underlying driving forces of land cover changes.

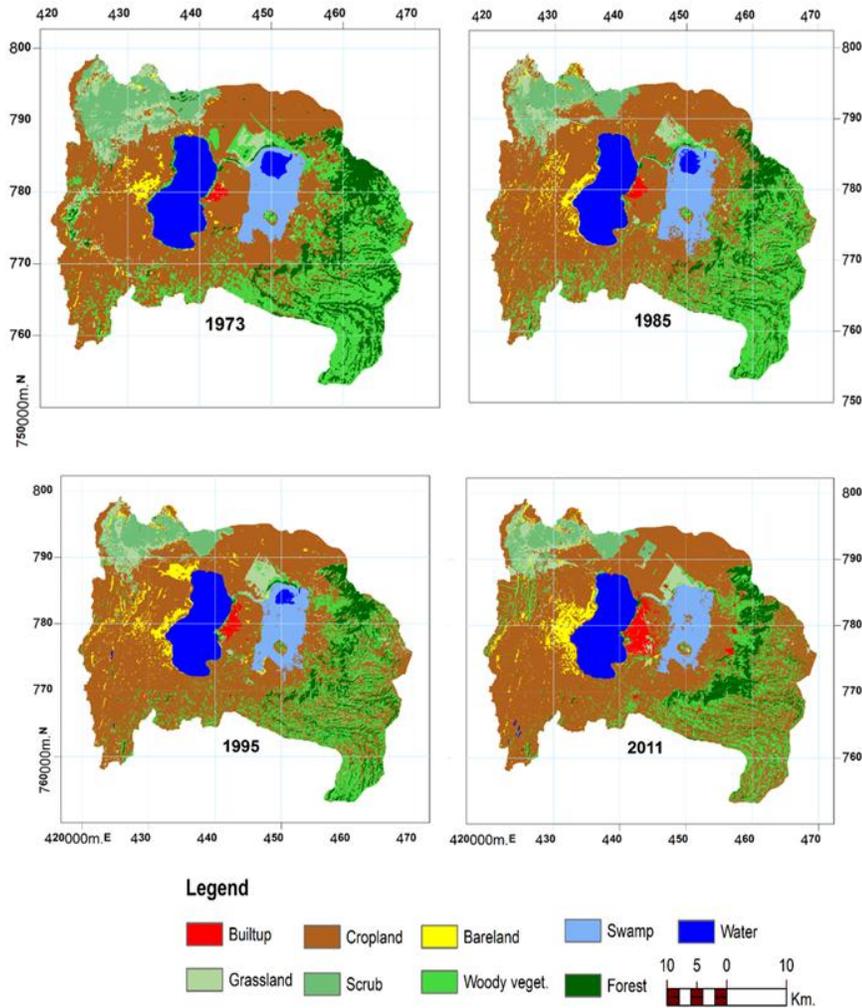
**Figure 5.** Land cover maps of the Lake Hawassa Watershed at four temporal instants. Source (Wondrade et al., 2014)

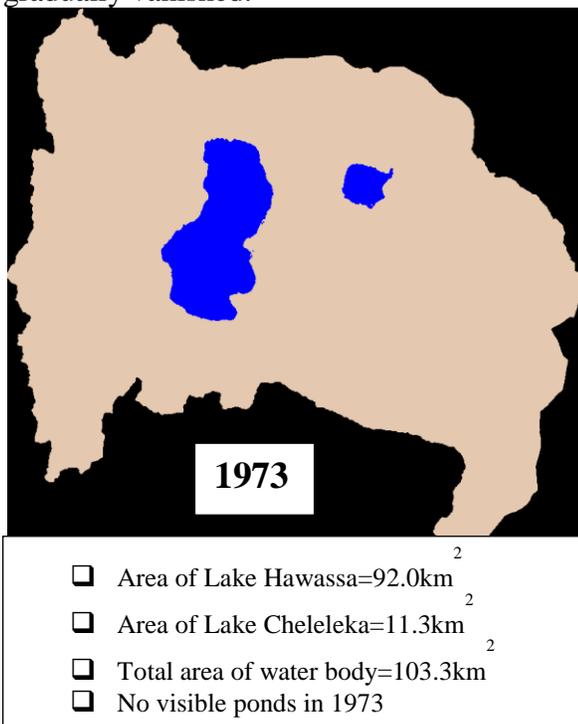
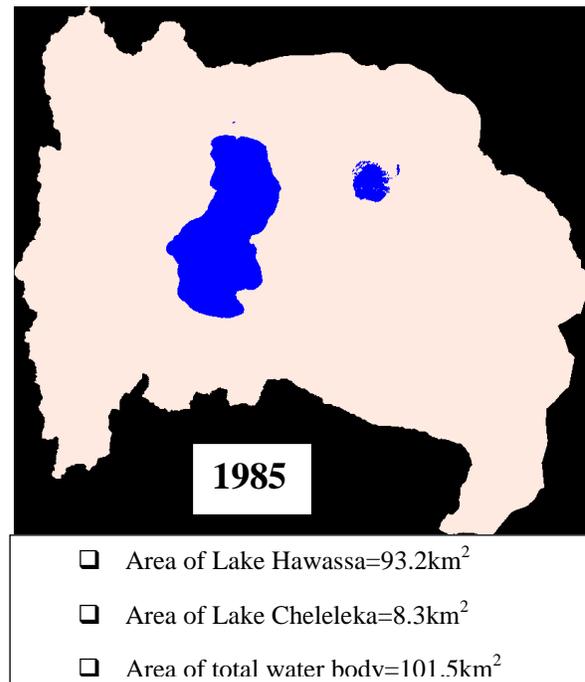
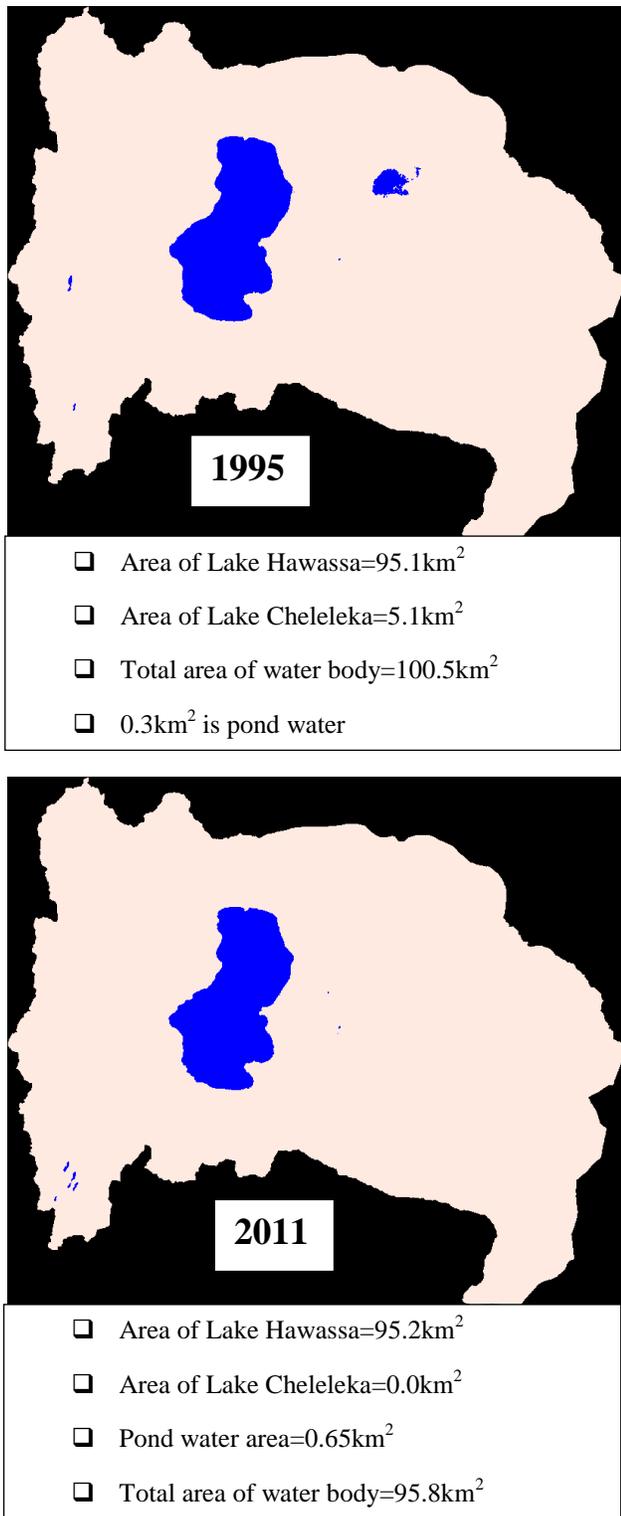
The analysis revealed that the surface area of Lake Hawassa has increased by about 3.5km<sup>2</sup> between 1973 and 2011 while Lake Cheleleka has gradually vanished.

**Figure 6.** Trends of change in water body. Source (Wondrade et al., 2014)

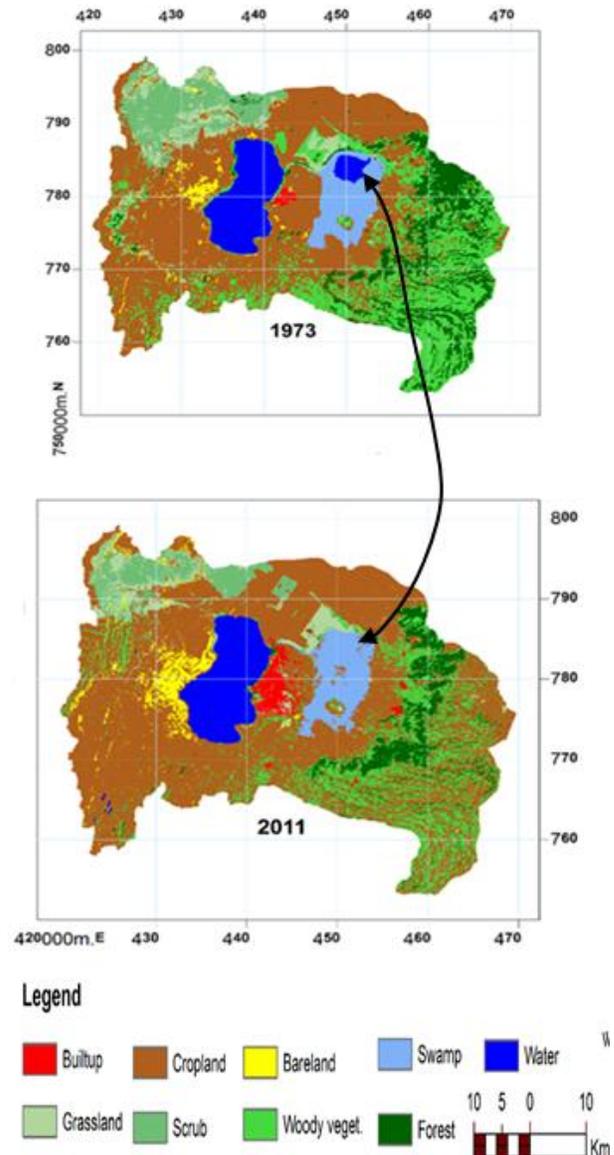
The area of Lake Cheleleka was 12km<sup>2</sup> in 1972 (Ayenew, 2004) and 11.34km<sup>2</sup> in 1973 (Wondrade et al., 2014) in 1972 and 1973, respectively. The average depth was 5m having a total volume 60x10<sup>6</sup> m<sup>3</sup> in 1972. However, Lake Cheleleka is today a mud flat and grass dominated swamp (see Figure 7).

**Figure 7.** The conversion of Lake Cheleleka into swamp between 1973 and 2011. Source (Wondrade et al., 2014)

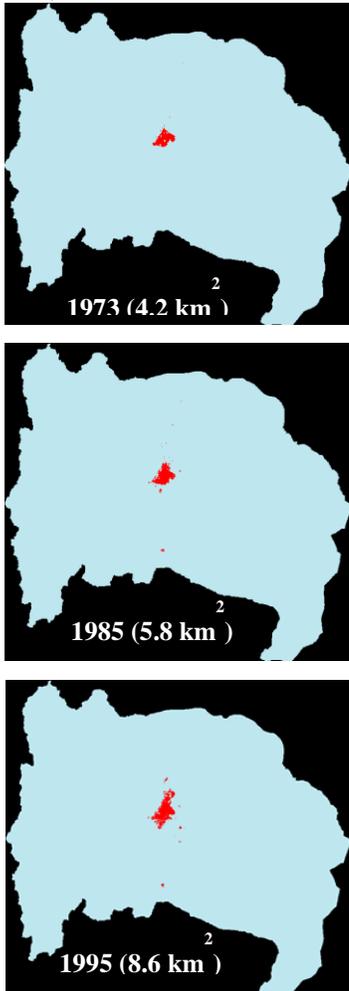
Though small in absolute terms, built-up area has increased by 480% between 1973 & 2011. Particularly, the expansion was significant since 1995. Urbanization is one of the most dynamic processes in the context of global and local land cover transformations. In 2025, Africa is expected to be urban by  $\approx 54\%$  and Ethiopia by 30% (World Resource, 1996).

**Figure 8.** The trends of change in built-up area. Source (Wondrade et al., 2014)

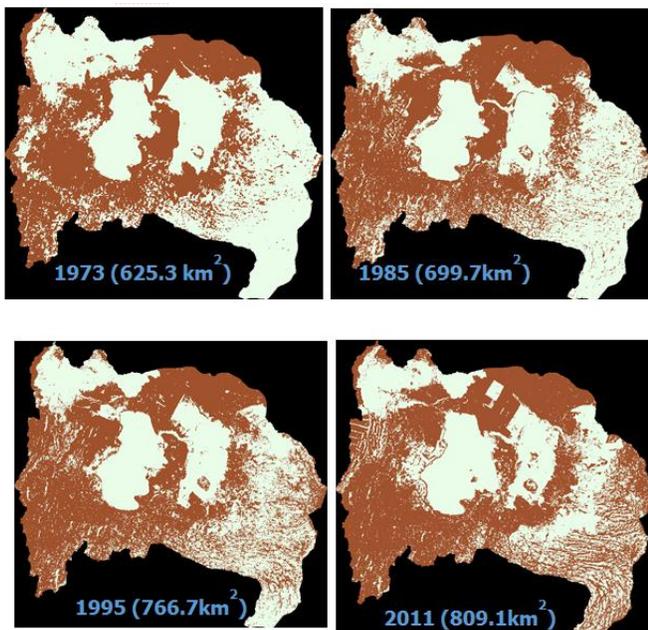
The analysis of cropland revealed a slight deceleration in cropland expansion both at annual and temporal rates. This slight deceleration in the expansion of cropland could be attributed either to shortage of suitable land for further conversion or that the remaining area cannot be used for cropping due to policy restrictions or natural barriers.

**Figure 10.** Trends of cropland expansion. Source (Wondrade et al., 2014)

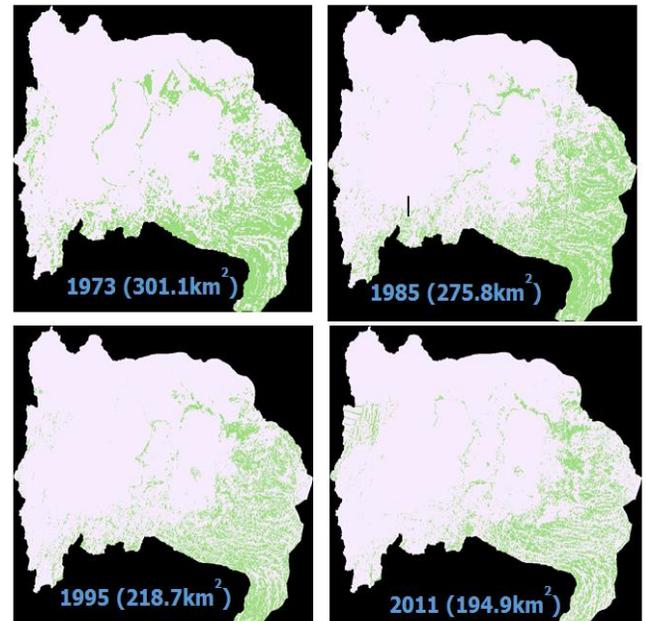
Woody vegetation constantly declined throughout the study period and the highest was -20.7% that occurred between 1985 & 1995. This time coincides with the regime change in Ethiopia where control over resource was loose. Western

The loss of woody vegetation is caused by high demand for fuel wood & construction materials, cropland expansion, weak law enforcement, power vacuums during regime changes, urbanization, freely roaming livestock etc.

**Figure 11.** Trends of change in woody vegetation. Source (Wondrade et al., 2014)

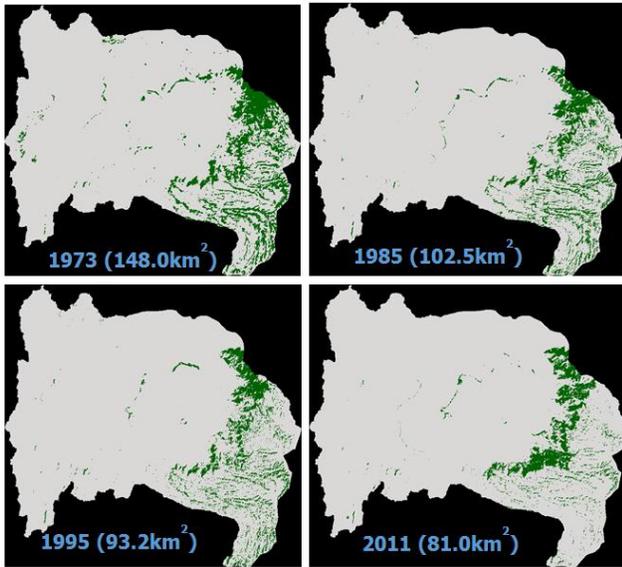
Forest experienced continuous decline, -30.8% from 1973 to 1985 and -13.1% from 1995 to 2011 period with a -1.2% annual rate of change during the whole study time. Causes of decline in forest cover are more attributed to human induced factors, such as illegal logging & selected felling of trees, extraction of fuelwood and construction materials, loose law enforcement, forest fire & soaring prices of timber products, expansion of rain fed agriculture, urbanization, proximity to big cities & road networks, overstocking of saw mills & joinery enterprises, etc.

**Figure 12.** Trends of change in forest cover.

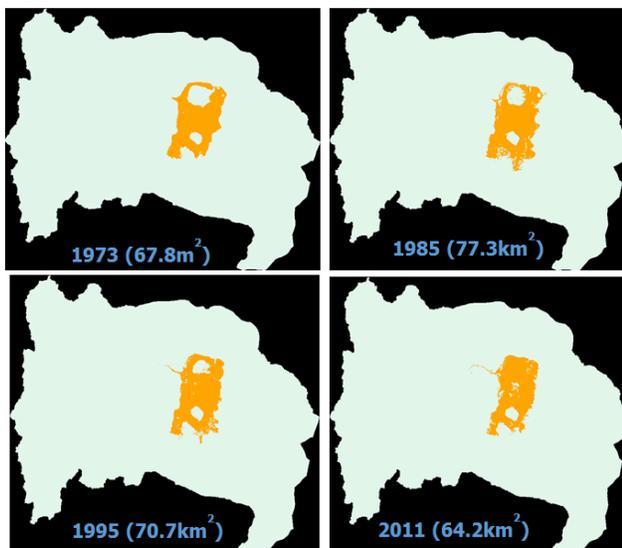
The wetland in 1985 was greater than that of in 1973, because of the continuous evacuation of water from Lake Chelelleka. As the Lake Chelelleka recedes, the area has been converted into mud flat & grass dominated swamp indicating the transported sediments have gradually filled the lakebed. Thus, the unprotected swampy area had continuously decreased as the result of cropland expansion.

**Figure 13.** Trends of change in wetland. Source (Wondrade et al., 2014)

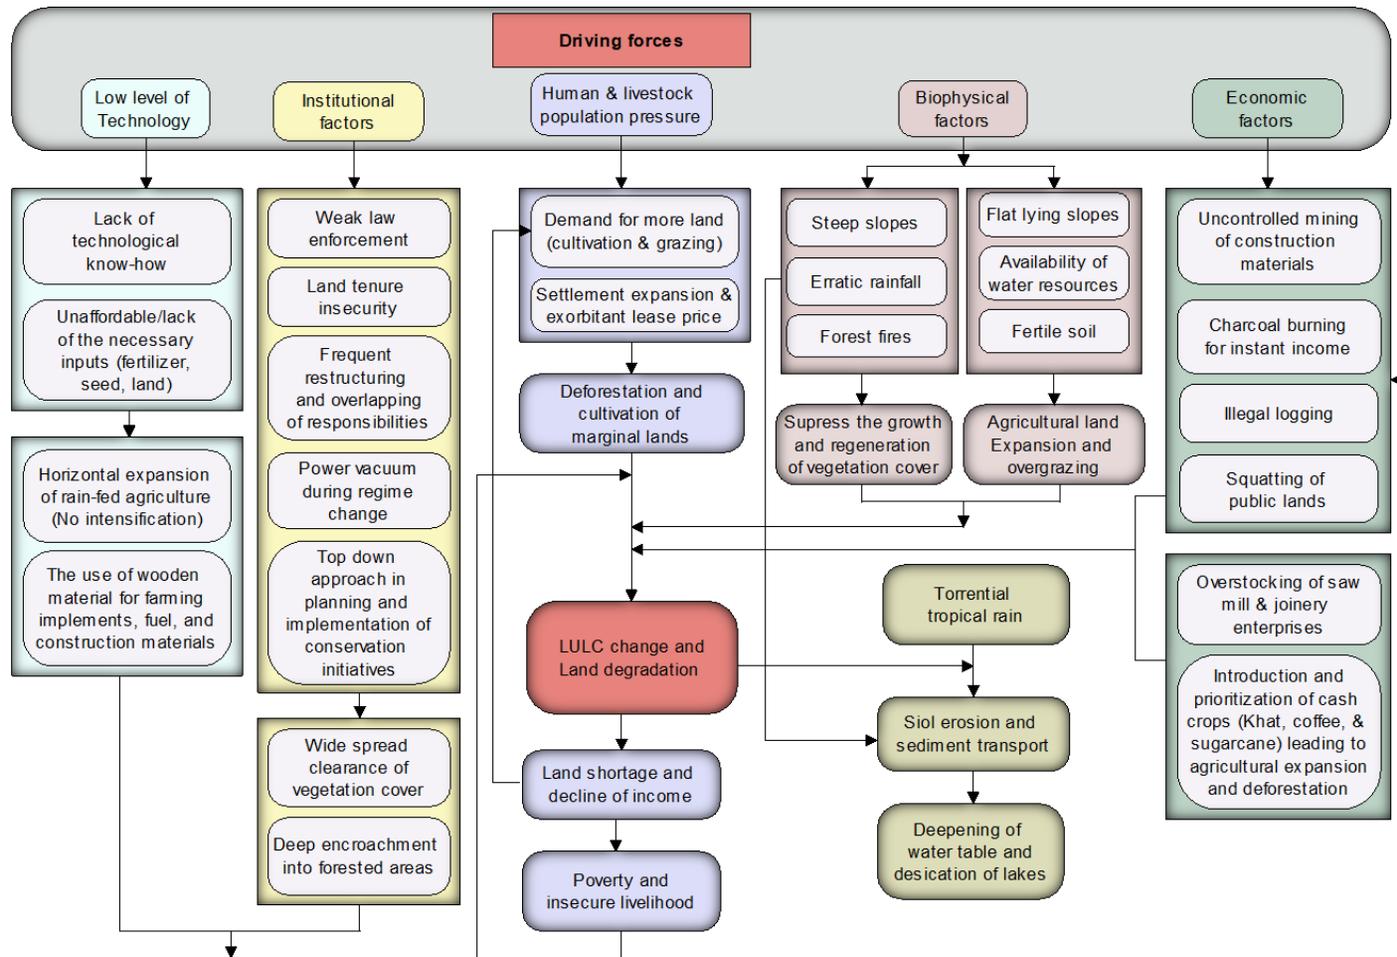
economic, and biophysical factors. Figure 16 illustrates the conceptualization of the links between LULC change and the identified driving forces.

**Figure 16.** Simplified representation of interaction between LULC change and the major driving forces. Source (Wondrade, 2015)

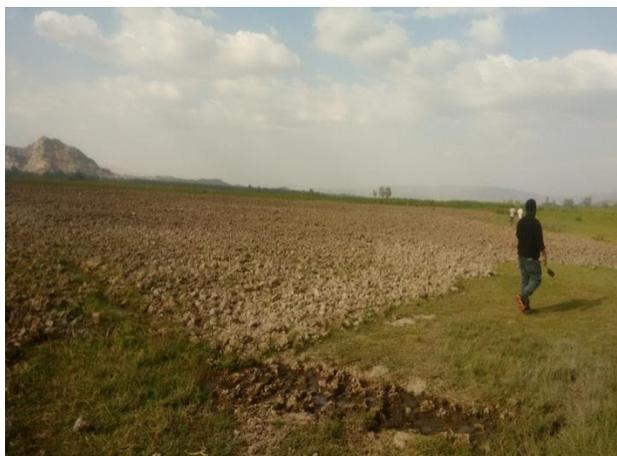
**Figure 2.** Farming practice inside the wetland downstream of Burkito Hot spring, north east of the wetland

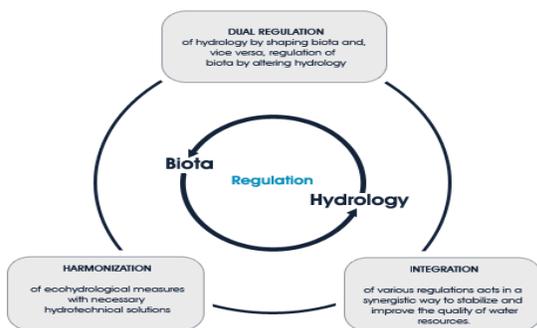
microbial enzymatic processes. The pattern and intensity of hydrological variability significantly moderate biotic structure and activity. On the other hand, biotic structures regulate abiotic ones: wetland and flood-plain plant-cover significantly determine the extent of river self-purification capability (Zalewski, 2002).

**Figure 3.** Integration of biological process and hydrology

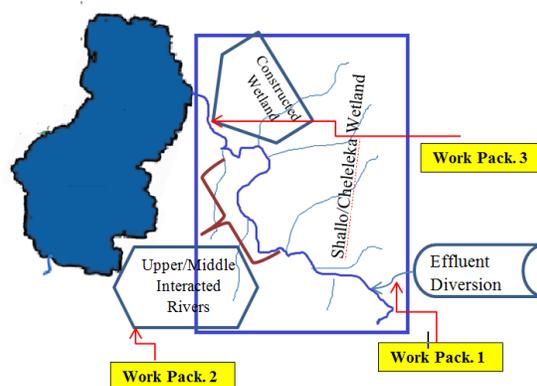
**Figure 4.** Schematic representation of three work-packages (Work Pack.) suggested being in place for an Ecohydrological intervention in Cheleleka Wetland

In light of the theoretical background elaborated above, three work-packages are proposed as mitigation actions using ecohydrological approach. We have arbitrarily named them as work-packages 1, 2, & 3 with locations indicated in Figures 4 & 5.

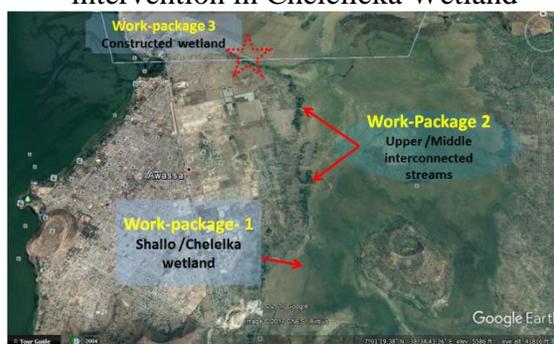
**Figure 5.** Satellite images depicting the suggested sites of the three work-packages for an ecohydrological intervention

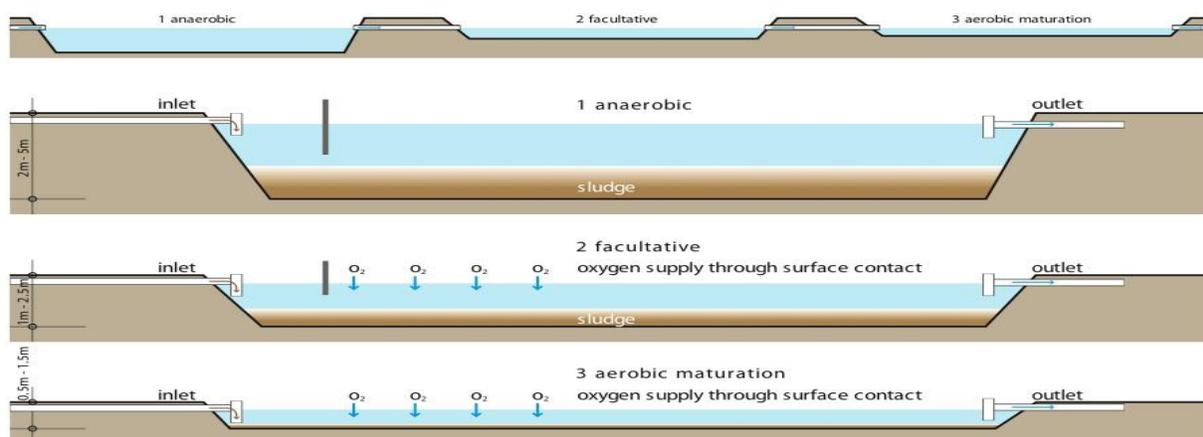
BOD is reduced to the possible minimum as a result of decomposition of organic matter in the anaerobic and facultative ponds. Thus the purpose of aerobic ponds is mainly removing pathogens and filtering/blocking solids. This purpose can also be extended to the removal of nitrogen and phosphorus (major nutrients responsible for eutrophication) when combined with harvesting of fish and/or algae. The amount of aerobic ponds required and their size rely on the desired final quality that depends on pH, temperature and light.

**Figure 6.** Details and arrangements of Anaerobic-Facultative - Aerobic ponds in series

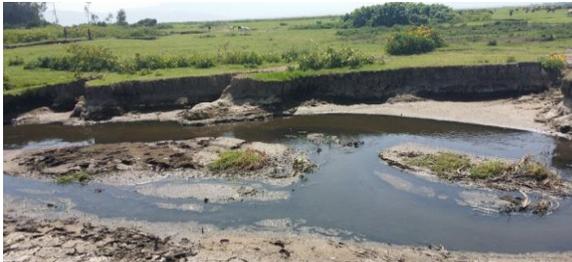
*Figure 7. Location 1 (just downstream of Cheffe Kote-Jebesaa Kebele) selected for modified riverine treatment.*

influence the BOD and turbidity of the water, among other variables, etc. These need to be removed before the River joins Lake Hawassa. Thus the purpose of package-2 is to remove the contaminants from the river at different reaches using natural treatment techniques with the provision of ample hydrologic retention time (HRT) for the flow with enhanced microbiological activities and for better phytoremediation actions. During a preliminary reconnaissance study conducted in November, 2018; three places were identified for possible modification along the main stream and its tributaries (Figures 7, 10 & 11) using the existing endemic macrophytes while shaping the river/stream bank for better HRT.

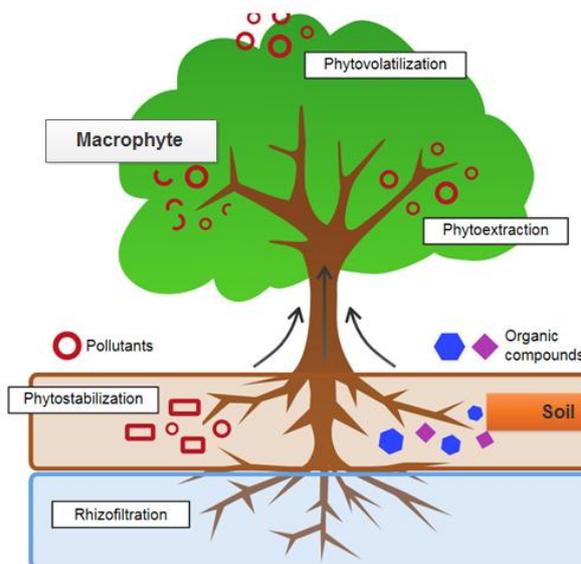
Phytoremediation (“phyto” meaning plant, and the Latin suffix “remedium” meaning to clean or restore) is a relatively new field of science and technology that uses plants to clean-up polluted soil, water, or air (Lamoureux, 2005). Phytoremediation can be applied to both organic and inorganic

**Figure 8.** Phytoremediation techniques (<https://en.wikipedia.org/wiki/Phytoremediation>)

pollutants present in soil, water and air. It consists of mainly four different plant-based technologies each having a different mechanism of action for the remediation of polluted soil, sediment, or water (Cunningham, 1995).

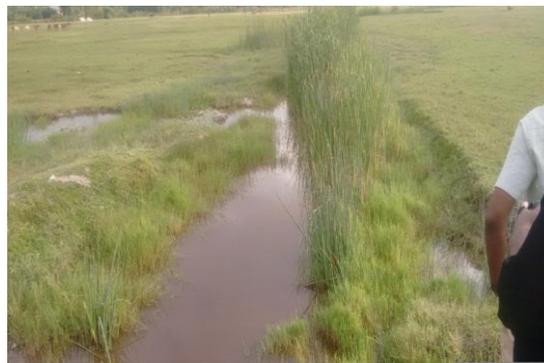
**Figure 9.** Location 2 (just downstream of Burkito Spring) selected for modified riverine treatment.

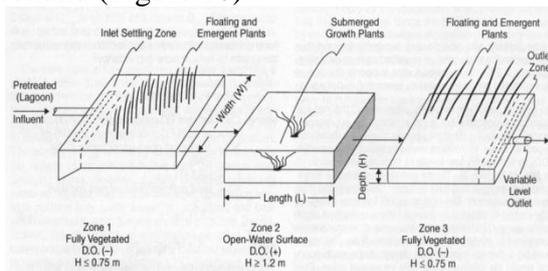
Based on either volume or area, there are a variety of different wetland design methods. Each method carries its own set of assumptions, and different sets of equation having their own strength and weaknesses. Volume-based methods use HRT for pollutant reduction (Reed et al., 1995) whereas areal-based methods assess pollutant reduction using the overall wetland area (Kadlec and Knight, 1996). Basically there are two designs of constructed wetlands, viz. surface flow and sub-surface constructed wetlands. In our case, we have opted to use the surface flow constructed wetland for the very reason that the technology has been tested under tropical conditions and is found to be cost effective, operation and maintenance friendly, and less demanding to modify the landscape (Mihret Dinanto, 2014 and references cited therein). To that effect, a three-zone Free Water Surface Flow (FWSF) constructed wetland model (adopted from USEPA, 2000) is suggested here for the proposed constructed wetland (Figure 10).

**Figure 10.** Typical Elements of FWSF Wetland, A 3-zone FWSF Wetland Model (adopted and modified from USEPA, 2000). **Zone- 1** is a densely vegetated region designed for flocculation and sedimentation of influent suspended solids and BOD. **Zone -2** is an open water region designed to increase the dissolved oxygen content of the water, allowing for aerobic degradation of soluble BOD

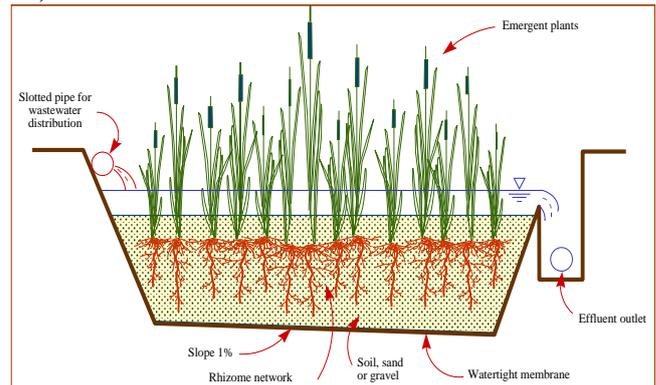
**Figure 11.** Free Water Surface Flow Constructed Wetland

The function of such wetland is mainly accomplished as the water goes through it where pathogens are eliminated, big particles stabilize and the rest of the contaminants are consumed by plants as food.

Free Surface Flow Constructed Wetland is composed of plants (Figure 14) in series (Figure 12) inside basins to reproduce water flowing through natural wetlands (Figure 13).

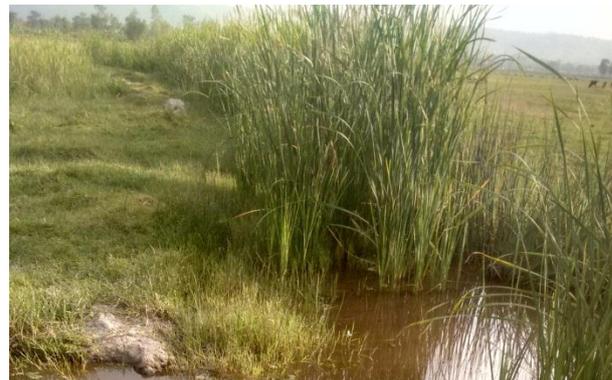
**Figure 12.** Typical FWSF macrophyte native to Chelelleka Wetland near Monopol Quarry site.

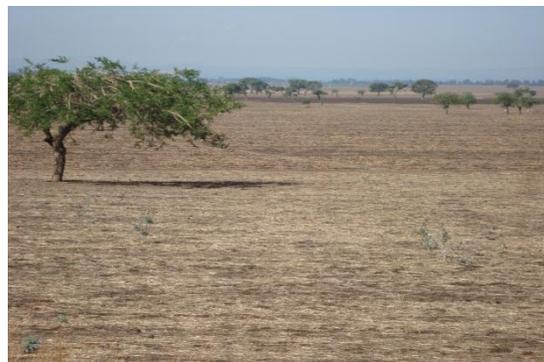
**Figure. 1** ELFORA Mechanized Farm partial view, April 2017.

*Elffora mechanized Farm (Figure 1)* is located in the north and north east part of the wetland. The total area of the farm is over 3000ha, out of which 2600ha is used for growing different types of crops. Maize, Alpha-alpha grass, and vegetables such as green pepper and tomato are grown by the farm. Chemical fertilizers (UREA, and DAP), herbicides and insecticides are used to boost production and productivity of the farm. The farm provides employment for 400-600 seasonal and 55 permanent workers. The farm allows free access to the local farmers to use the crop aftermath for their livestock feed.

We verified that in this part of the catchment where there is agricultural activity, there is very little plant cover because of the increased tilling of the land and overgrazing of vegetation. Therefore, the soil is exposed to erosion. This has been the trend since long. Such land use and degradation of the catchment led to the runoff with increased input of sediments (soil and nutrients) that have negative impacts on the lake.

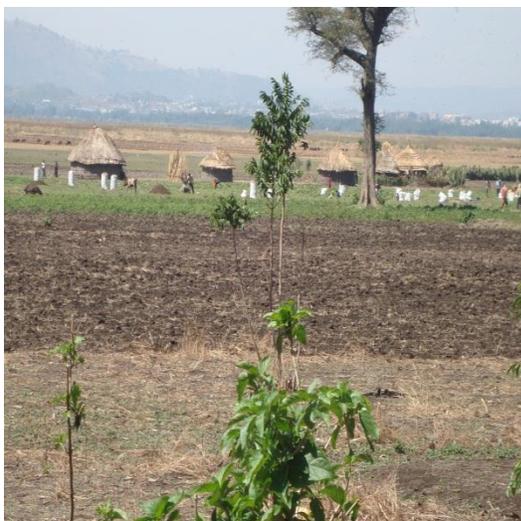
**Figure. 2.** Land grabbing and irregular house construction, December 2017

In the north and north west part of Chelelleka Wetland, there is land grabbing (Figure 2). and irregular house construction (Figure 3). Currently we have observed that there are over 500 housing units in the area. The settlers are mainly from Shire Borera and Woransa Kebeles of Wendo Genet Woreda. With estimated average family size of 5, the total human population currently residing in the area is estimated to be about 2500. So many new huts are still under construction in the area.

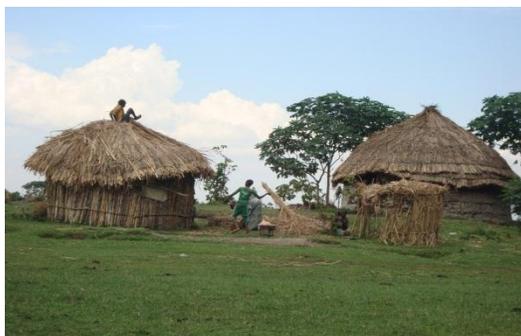
**Figure 3.** Irregular settlement on northern part of wetland in November 2018.

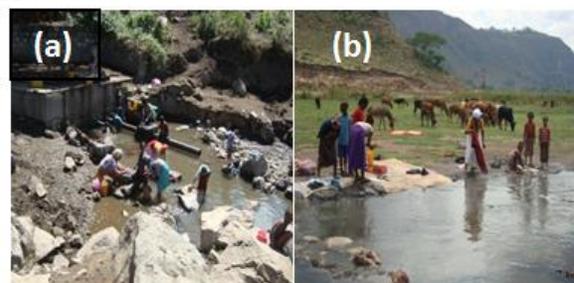
**Figure 6- a.)** Tulu spring for washing cloth and domestic items; b) Hot spring for washing purposes, December 2017.

Tutu spring is the major water source for the people who settled around in the northern part of the wetland. It comes out of the foot of a big mountain in the upland. It has been built and developed to supply water to the community living in the area. This spring is serving as a major source of drinking water for human and domestic animals and for washing clothes. Some people come to fetch water from distant place such as Toga village. These activities affect the volume of water

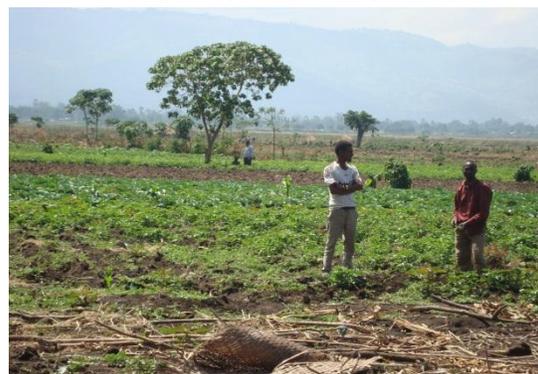
**Figure 7.** Tulu spring is used for vegetable irrigation at the northern part of the wetland, December 2017.

Tulu spring is also being used to irrigate farmlands for the cultivation of vegetables. Farmers usually grow potato, onion, tomato and cabbage. Vegetable production has been important economic activities to get income though supplying them for markets in Hawassa and Shashemene cities. According to the local people, farm expansion into the wetland has become a common phenomenon. The size of Shallo Swamp is consequently declining and may eventually dry totally. The overall effect of this in turn would be detrimental to the size of Tikur Wuha River and that of the lake .

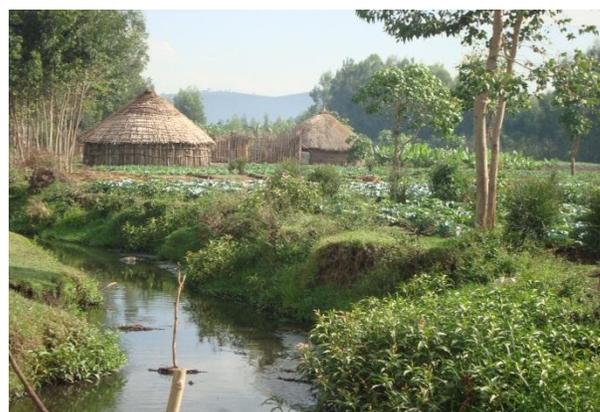
**Figure 16**- Irregular housing in the wetland with vegetable farming, December 2017.

recently about 400 persons were accused for irregular house construction and farming activities around/ in the wetland. The kebele chairperson disclosed that the kebele with Tula sub city and police force made a survey around the wetland and found the aforementioned number of individuals for the irregular acts. Besides, the kebele detains individuals who carry/transport eucalyptus tree into the middle of wetland for house construction. It was also evident during field visits that the wetland has been under pressure from the periphery and inside due to house construction and farming activities.

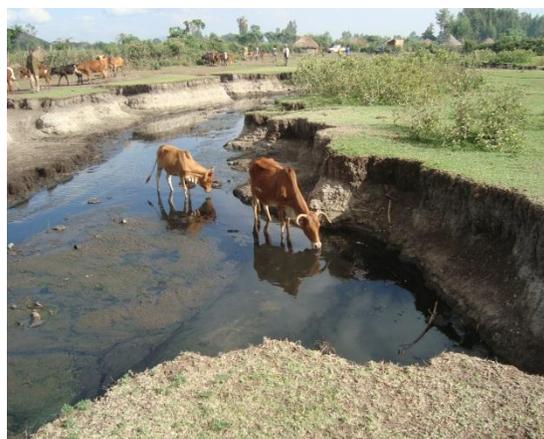
Moreover, when animals move for grazing into and from the wetland, they drink and contaminate it with the waste. Fetal abortion, reduction in milk production and discoloration of milk and body emaciation have been

prevalent effects observed on livestock. Under worst scenarios, these occasionally result in the death of animals.

**Figure 18-** Industrial effluents are drunk by livestock, December 2017.

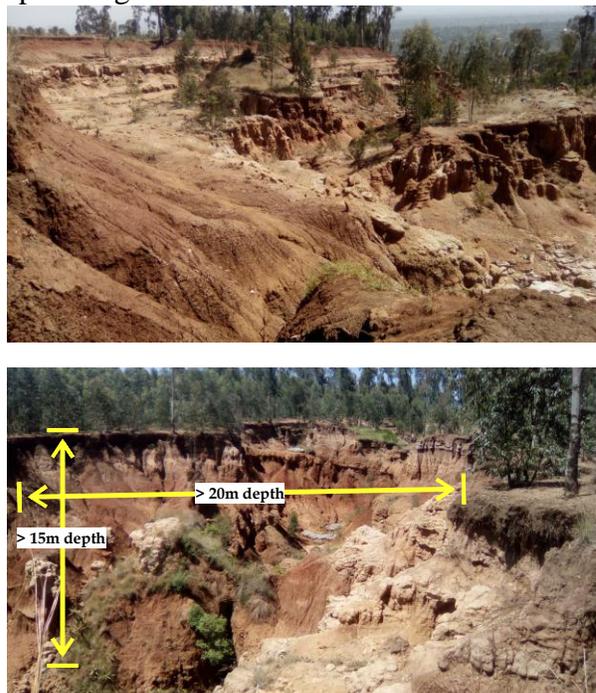
*Figure 1. Partial view of gully head at Yirbadubancho Kebele (Boricha wereda)*

The gully network under consideration can be categorized as large gully systems in deep sandy soil (Figure 1) lateral or side headcuts or overfalls that frequently develop where small side drainages flow over the rim of the main gully. Unfortunately, the Boricha gully has passed the labeling of 'early-stage' treatment. However, it must be treated as soon as possible to avoid further expansion. This demo site is dedicated to search for best-fit gully treatment options by respecting the design and construction principles formulated

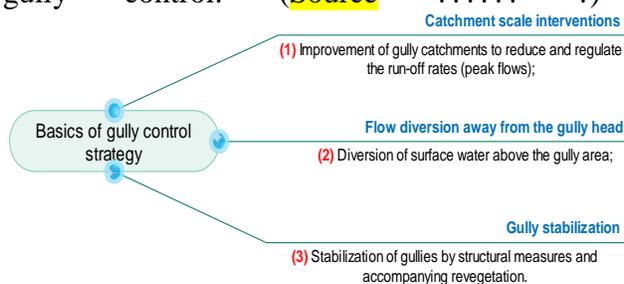
**Figure 3.** Basics of gully control strategy

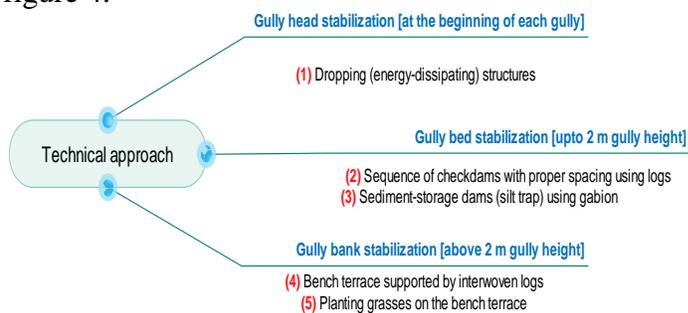
**Figure 4.** Segmentation of gully treatment activities

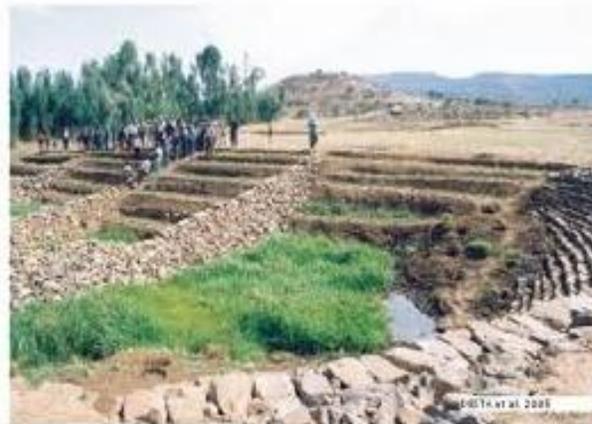
### [Box 1] Gully head treatment

- Divert excess runoff into another drainage line (stable) or treat the catchment area.
- Control the gully head and the side banks by cutting & filling (see figure above in Box 1)
- Gully heads can be stabilized by the means of stepped stone carpets, brushwood layering or a combination of both.
- Using stepped stone carpet is more appropriate for dry areas because of intensity of rainfall.

The stepped stone carpet occurs following the semi-circular shape of the gully head, moving backwards and filling empty space with soil and small stones until it reaches the gully edge.

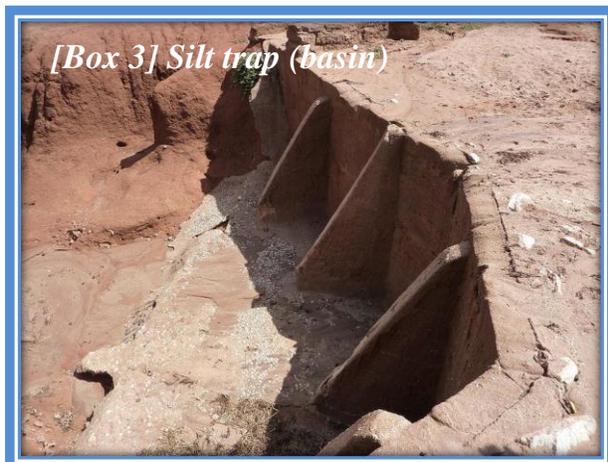
**[Box 3] Silt trap (basin)**

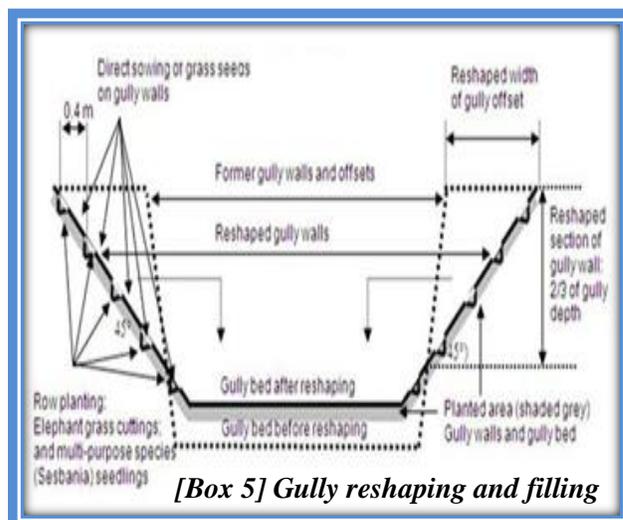
**[Box 5] Gully reshaping and filling**

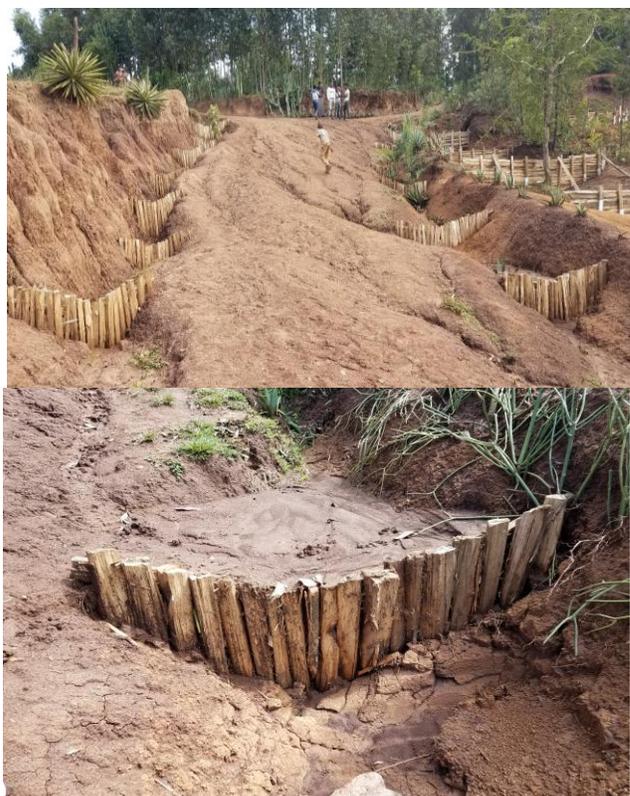
**Figure 8.** Checkdams above the gully head

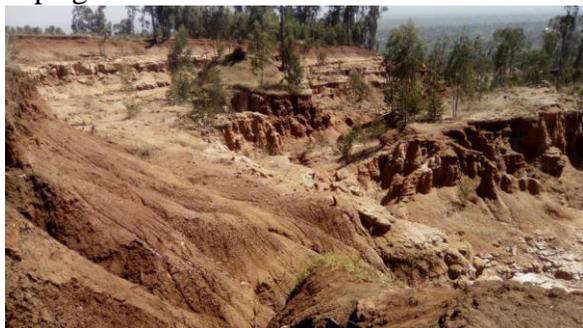
**Figure 10** Partial views of gully head at Yirbaduwancho Kebele

A combination of simple and low cost structural and biological conservation measures were implemented using locally available materials such, wood and grass. The major cost was payments for wood, grass seedlings and daily labour. The gully areas were not in good condition for vegetative growth since the slopes are steep and the fertile topsoil had been washed away. It was hence difficult to establish vegetation and provide quick cover. Therefore, reshaping the steep walls was necessary. To reshape the steep slope, retaining wall is also required to stabilize and hold back the soil, and to reduce the risk of wall collapse. To construct the retaining wall, the first step was to mark out the contour line across the slope from the beginning to the end of the gully area. After marking the contour line, the wooden posts were anchored in to the ground at specified distance along the contour and across the

slope at various spacing depending on the slope gradient.

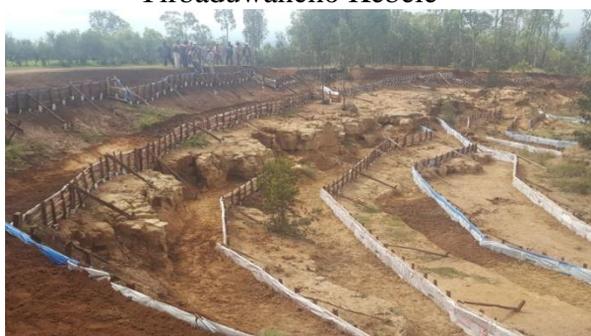
**Figure 11** Design improvements as suggested by the community

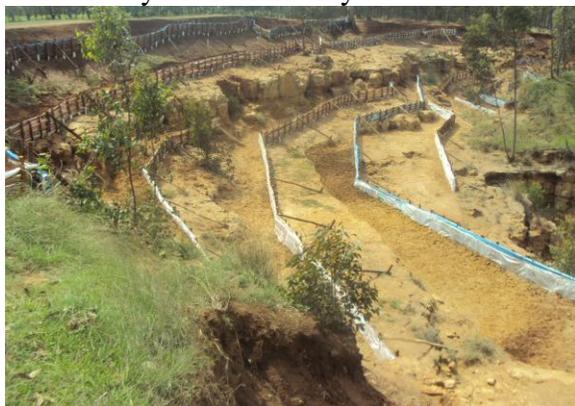
**Figure 12** After 25 days of the project start To keep the wooden posts firmly at their position, back stays were fitted at regular intervals. After completing the retaining wall construction, the slope that was in vertical position was reshaped to gentle slope by cutting and filling to the lower area to create a levelled bed. This bank slopping was necessary for establishing vegetation. What if you explain about the use of plastering of the

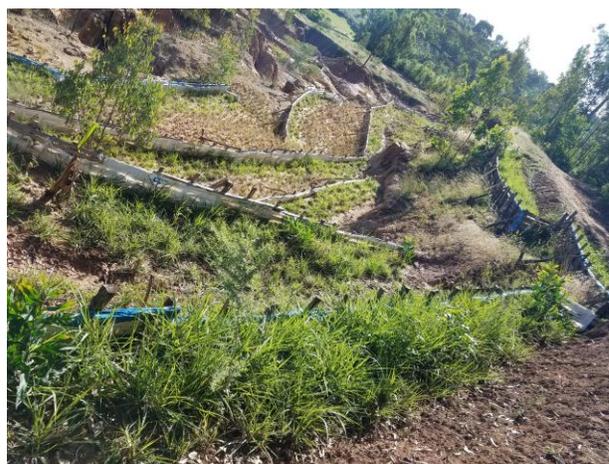
**Figure 14** Current statuses (after one rainy season)

Then *Pennisetum pedicellatum* (locally known as *desho*) and *Chrysopogon zizanioides* (*Vetiver*) grasses were planted on the reshaped slope and the bed with clump spacing of 15 cm within a row and 30 cm between rows. The *Pennisetum pedicellatum* was established by planting tillered cuttings while *Vetiver* was planted by splitting the culm. *Vetiver* was selected due to its ability to grow under dry and unfavourable conditions and control erosion with its dense root system binding the soil together. *Pennisetum pedicellatum* provides massive fibrous root system to stabilize the wall of the gully, vigorous

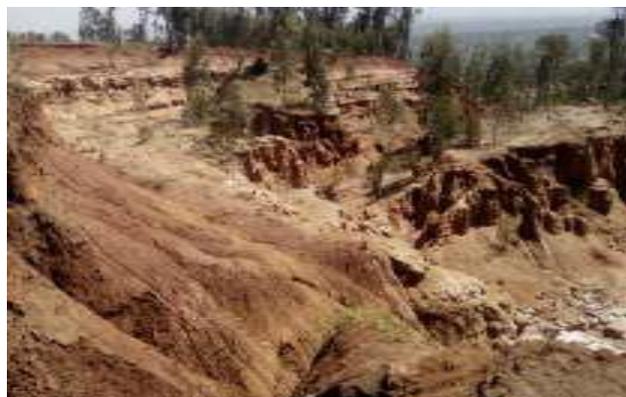
However, as the human and animal population increased and farming and settlement expanded over decades, land cover continued to decrease. The forests were affected because they were the sources of construction materials, household furniture, farm implements and fuel wood. In addition, in the early 1970s, high scale damage was done to the forests as it was a transition period from the imperial regime to Derg. As a result, the vegetation cover along with most of the local trees disappeared. Rain water (it was heavy at that time) which used to be absorbed by soil, began to run away causing erosion. Through time the erosion became intense and gave rise to gully formation which. was first noticed towards the end of Emperor Haileselasie I regime, and continued to expand and to grow wider and deeper, as can be seen from figure 1below.

**Figure.2:** Partial view of gullies in Yiba Dubancho

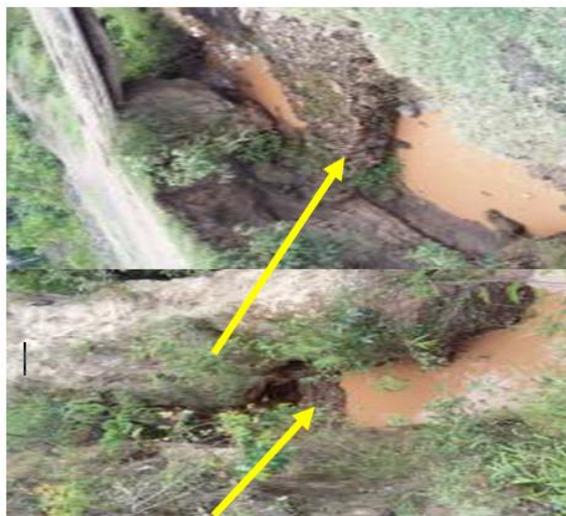
**Figure 5.** Gabions constructed in the gully beds

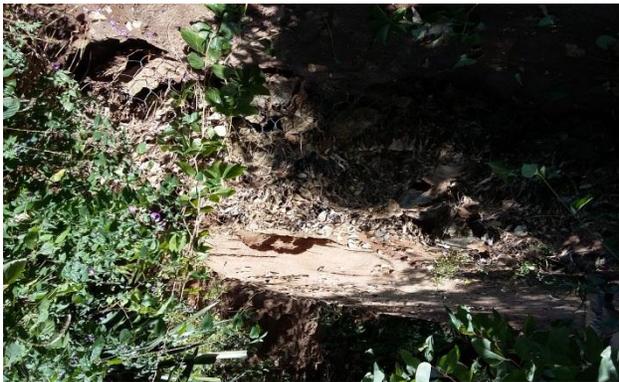
**Figure 6.** A broken gabion in the gully bed

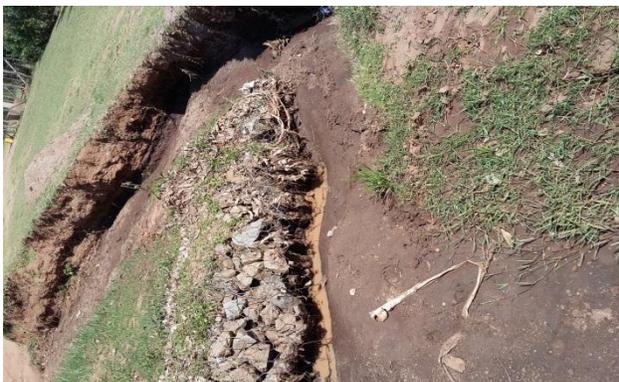
the deep gully beds and plain areas in the lower stream are contributing in reducing the degradation, but at different points some of the gabions were broken/washed away by heavy gullies, or the erosion is expanding sideways destroying the gully banks (fig .6 & 7). Despite this fact, the participants expressed their worries relating to the absence of maintenance scheme to the gabions. Moreover, since gabion work was begun in the lower stream, the magnitude of erosion from the upper steam has not reduced much, and this is making the effort less effective than it would do in the lower stream. Thus, still more and more sediment is discharged and is entering Lake Hawassa thereby threatening its existence. In the face of this problem, the communities expressed that their financial and technological capacities are limited to tackle the problem since the gullies are very huge.

**Figure 7:** Gully eroding the bank on the sides
